Manhole Inspection Summary

Manhole # S63A1_004MH

Insp Date: **3/5/08 9:28 AM**

Location Address: **2220 Vail St.**

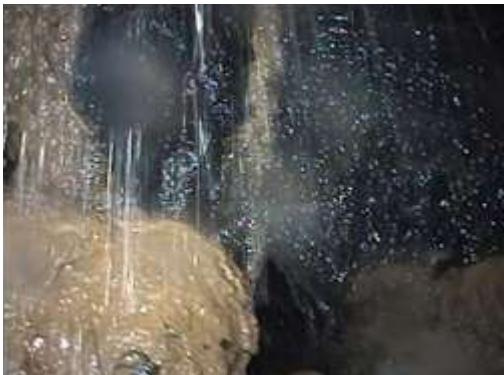
Defect 1

Comments **DROP CONNECTIONS ARE PARTIALLY CLOGGED AND CLOGGED. STRUCTURALLY THE MANHOLE IS IN "GOOD" CONDITION. CLOGGED DROP CONNECTIONS MAKE THIS LOOK WORSE THAN IT IS.**

Clogged drop line on incoming 9 o'clock

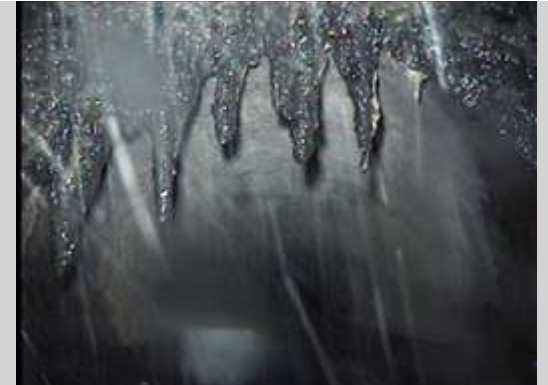
12 O'Clock Outflow

36 in. Circular Gravity Sewer
Pipe Out @ 12 O'Clock

Pipe Height: **34.8** (in.) Rod and Bar (Angled)
Pipe Material: **Concrete** ☐ Pipe Lined
Invert Depth: **23.67** (ft.) Flow Characteristics: **Fast**
Deposits: ☒ None ☐ Mud ☐ Sludge ☐ Debris ☐ Grease
Silt Depth: (in.) Deposits Extent:
Infiltration: **None** Pipe Seal Cond: **Sound**

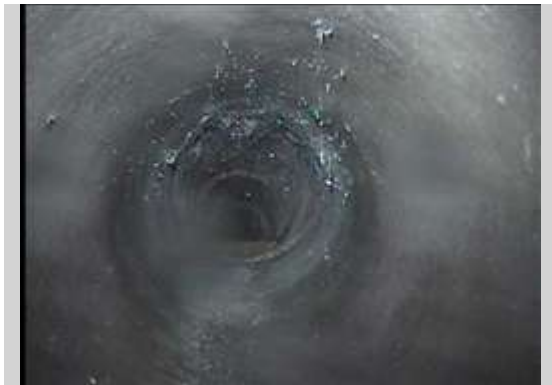
3 O'Clock Inflow

8 in. Circular Gravity Sewer
Pipe In @ 3 O'Clock

Pipe Height: **8.4** (in.) Rod and Bar (Angled)
Pipe Material: **Clay** ☐ Pipe Lined
Invert Depth: **15.25** (ft.) Flow Characteristics: **Fast**
Deposits: ☒ None ☐ Mud ☐ Sludge ☐ Debris ☐ Grease
Silt Depth: (in.) Deposits Extent:
Infiltration: **None** Pipe Seal Cond: **Sound**

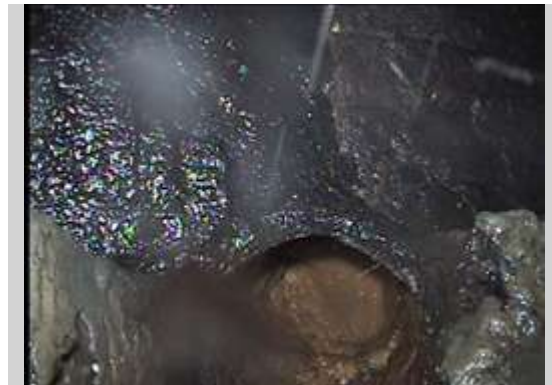
Drop In @ 3 O'Clock

Drop: **Inside** Rod and Bar
Angled: **Yes** Reading: **20.67** (ft.)
Inv Depth: **21.67** (ft.)
Drop Condition: **Partly Clogged**

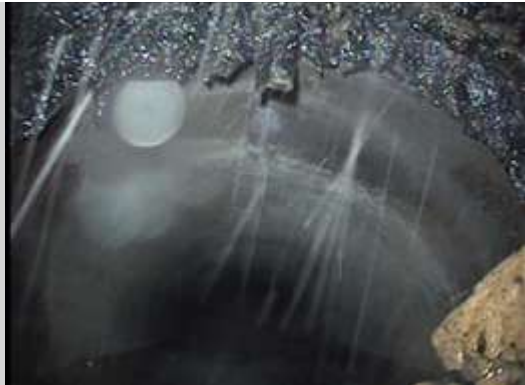
6 O'Clock Inflow

Pipe Height: **33.6** (in.) Rod and Bar (Angled)

Infiltration: **None** Pipe Seal Cond: **Sound**

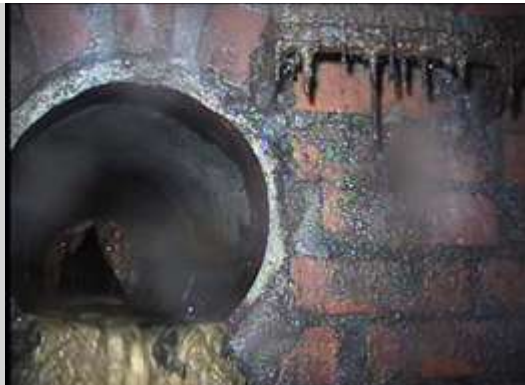
9 O'Clock Inflow

Deposits: ☐ None ☐ Mud ☐ Sludge ☒ **Debris** ☐ Grease

Silt Depth: **3** (in.) Deposits Extent: **Heavy**

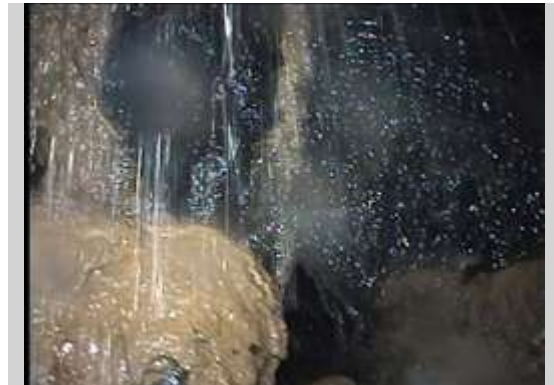
Drop In @ 9 O'Clock

Drop: **Outside** Rod and Bar
Angled: **Yes** Reading: **20.50** (ft.)
Inv Depth: **21.50** (ft.)

Drop Condition: **Clogged**
